# Exhibit D

Servicing Branch	4092	Contract Number	REDACTED
Customer	FAMILY DOLLAR DISTRIBUTION	Premise Number	2
	DC202-WEST MEMPHIS	Visit Type	SERVICE MAINTENANCE
	1800 FAMILY DOLLAR PKWY	Visit Date	03/17/2021
	WEST MEMPHIS		
	AR		
	72301-2974

Order Number	Status	Service Date	Report Description
57900525000	Completed	03/17/2021	COMMERCIAL PEST GENERAL MAINTENANCE SERVICE

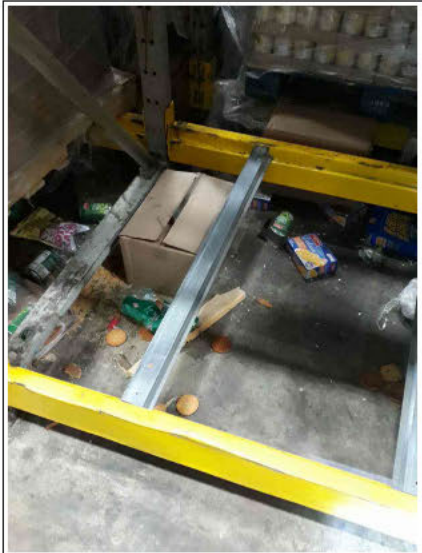
Location: Aisle 32 Snaptraps

An accumulation of food product from damaged goods noted. Please remove food product to prevent attraction by pests.

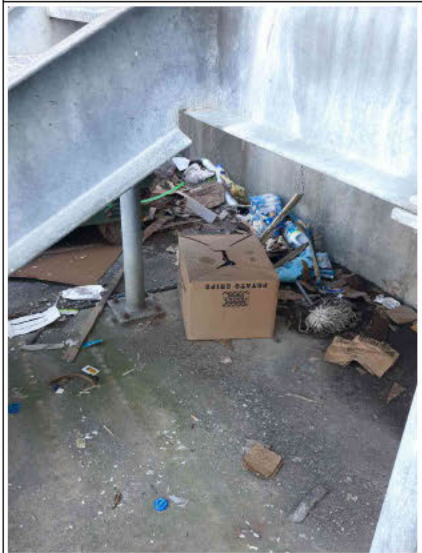
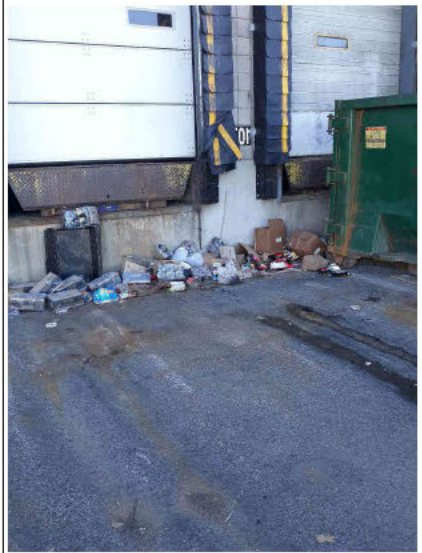
Location: RBS 025

Debris collecting in and around dumpster/compactor. Please remove debris to prevent unsanitary conditions and attraction by pests.

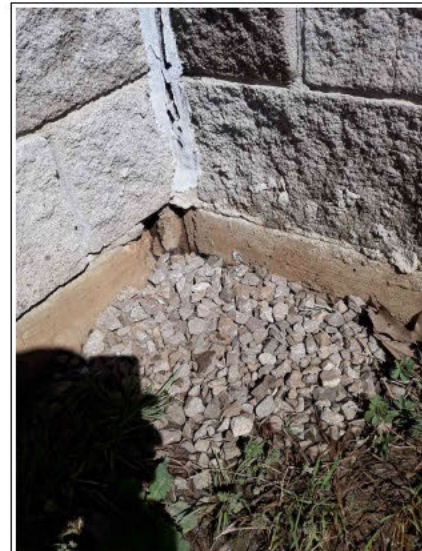
03/04/2021 Building: Building  
 Floor: Main  
 Reference: Zone: Exterior  
 250 Location Area: External  
 Location: RBS 060

Status:NEW  
 Type: Structural  
 Responsibility:  
 Cracks or damage to wall allowing pest access. Please repair to prevent pest entry.

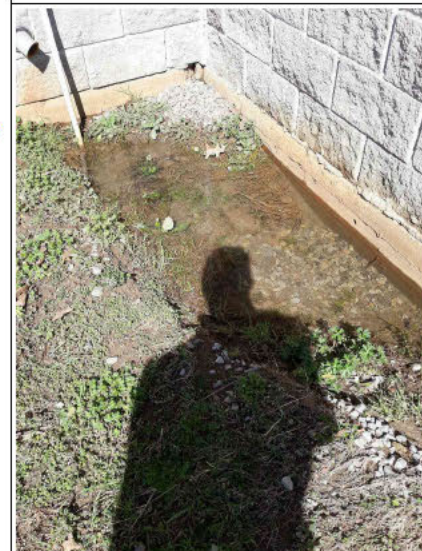
03/04/2021 Building: Building  
 Floor: Main  
 Reference: Zone: Exterior  
 249 Location Area: External  
 Location: RBS 060

Status:NEW  
 Type: Structural  
 Responsibility:  
 Water leak/standing water outside. Please remove water and repair leak to prevent unsanitary conditions and attraction by pests. By the red fire alarm on the west side of the building.

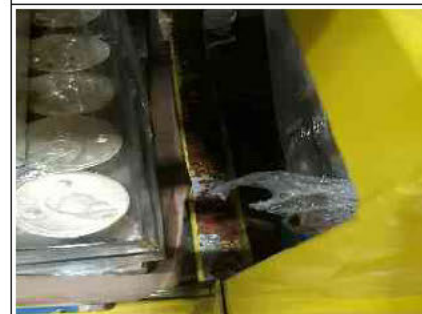
02/10/2021 Building: Building  
 Floor: Main  
 Reference: Zone: Warehouse  
 247 Location Area: Internal  
 Location: Aisle 28 Snaptraps

Status:NEW  
 Type: Sanitation  
 Responsibility:  
 An accumulation of food product from damaged goods noted. Please remove food product to prevent attraction by pests.

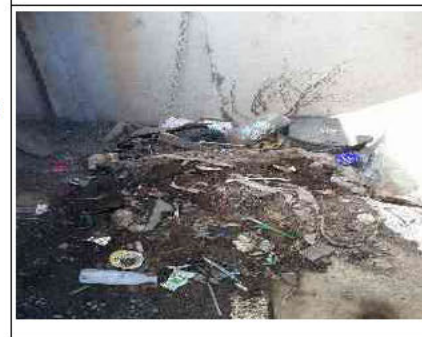
02/03/2021 Building: Building  
 Floor: Main  
 Reference: Zone: Exterior  
 246 Location Area: External  
 Location: RBS 017

Status:NEW  
 Type: Sanitation  
 Responsibility:  
 An accumulation of non-food product from damaged goods noted. Please remove product to prevent attraction by pests.

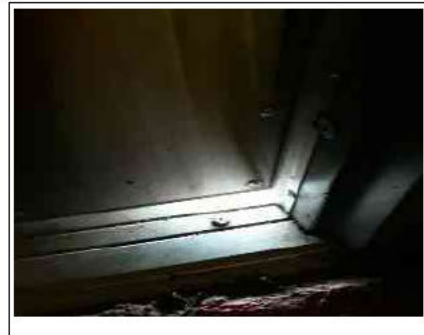
01/27/2021	Building: Building Floor: Main Reference: 245 Zone: Warehouse Location Area: Internal Location: MRT 061	Status:NEW Type: Sanitation Responsibility: Dog food pulled up under partly open dock bay door. please remove.
01/27/2021	Building: Building Floor: Main Reference: 244 Zone: Warehouse Location Area: Internal Location: Warehouse Insp	Status:NEW Type: Sanitation Responsibility: An accumulation of food product from damaged goods noted. Please remove food product to prevent attraction by pests. Unknown liquid spill located in front of 34-01-00
01/15/2021	Building: Building Floor: Main Reference: 243 Zone: Warehouse Location Area: Internal Location: MRT 095	Status:NEW Type: Structural Responsibility: Door gap/damage noted that allows pest access. Please repair to prevent pest entry.
